# KIX Early Recovery Plan

September 12, 2018

# Our Early Recovery Plan

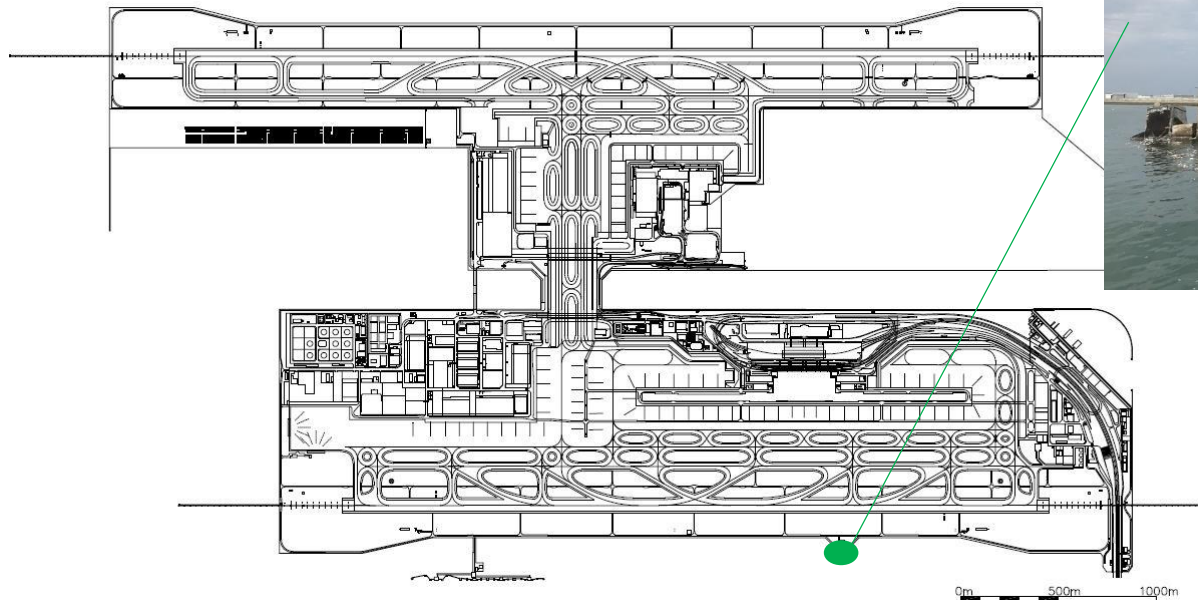
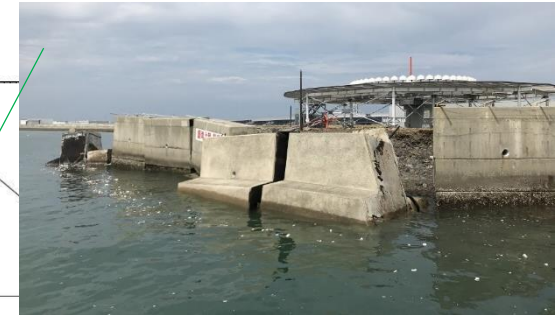
No.	Date	September 7	September 14 (After 1 week)	Efforts
1	Sept 7	Partially collapsed (see below)	Tentatively recovered by installing sandbags and filter units	Installation of sandbags completed. <b>Expected to install filter units on Sept.13.</b>
