KIX Early Recovery Plan

September 10, 2018

Our Early Recovery Plan

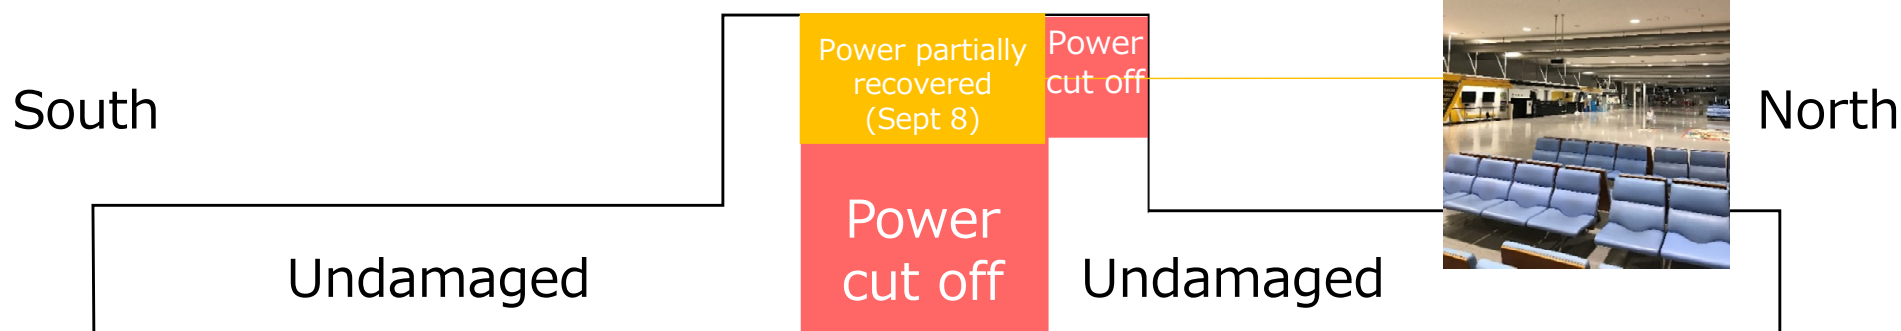
Electricity recovery situation

| No. | Date | September 7 | September 14 (After 1 week) | Efforts |
|---|---|---|--|--|
| 1 | Sept 7 | Lighting: partly outage Disaster prevention: flood damage (partly) AC: flood damage (partly) ES: flood damage on monitoring equipment EV: flood damage on monitoring equipment Service lane: drainage finished | Lighting: operational Disaster prevention: operational AC: partially fixed ES: operational EV: partially fixed | [Lighting, Disaster prevention] Full recovery expected on Sept 20 [AC, ES, EV] Drainage to complete Site investigations to start |

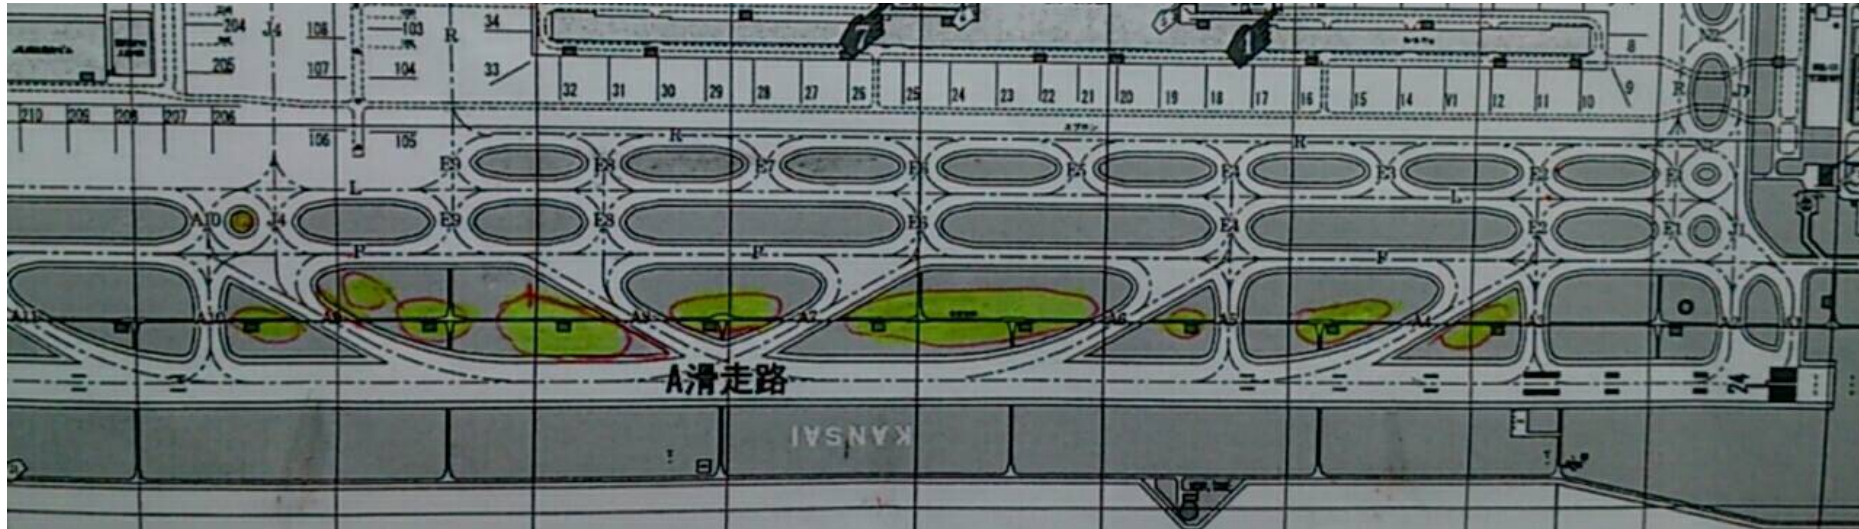
Sept 7
PM

| No. | Date | September 7 | September 14 (After 1 week) | Efforts |
|---|---|--|--|--|
| 1 | Sept 7 | <p>[Number of drainage facilities] 7 out of 10: In operation 3 out of 10: Under repair (Draining with the aid of pump vehicles provided by Kinki Regional Development Bureau)</p> <p>[Runway A and airfield lighting] • Pavements: Operational • Airfield lighting: partially damaged due to the flood</p> | <p>[Number of drainage facilities] 7 out of 10: In operation 3 out of 10: Recovered with provisional power source</p> <p>[Runway A and airfield lightings] • Pavements: Operational • Airfield lighting: Operational</p> | <p>[Drainage pump] • Provisional power generators under operation</p> <p>[Runway A and airfield lightings] • Surface cleaning by sweeper is ongoing. Some sweepers were borrowed from Narita Airport. Finished cleaning runway, taxiway and apron. Only some GSE roads are left uncleaned. • Recovery of damaged lighting and power source cubicle</p> |

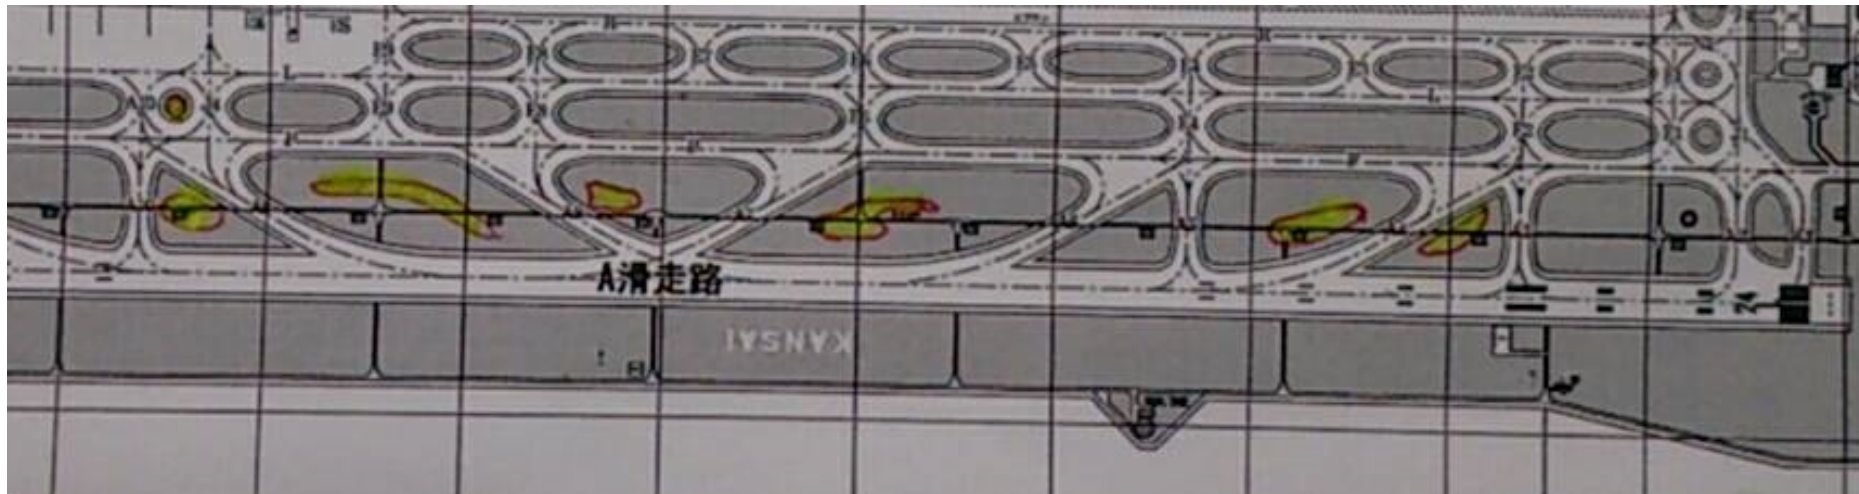
Sept 8
AM

No water pooling as of the evening of Sept 10

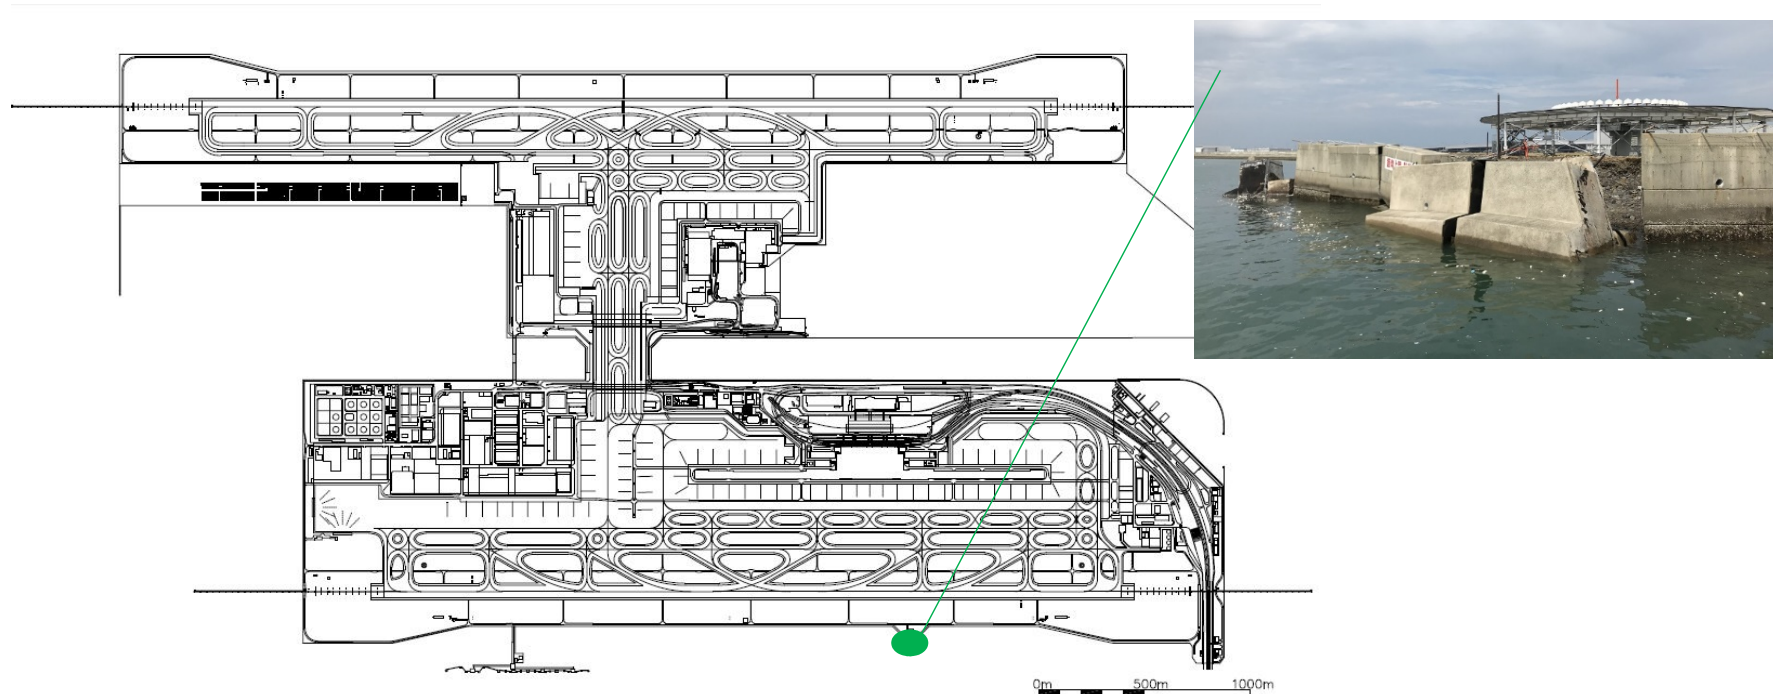
| No. | Date | September 7 | September 14 (After 1 week) | Efforts |
|---|---|---|---|---|
| 1 | Sept 7 | Partially collapsed (see below) | Tentatively recovered by installing sandbags and filter units | |
