# KIX Early Recovery Plan

September 11, 2018

# Our Early Recovery Plan

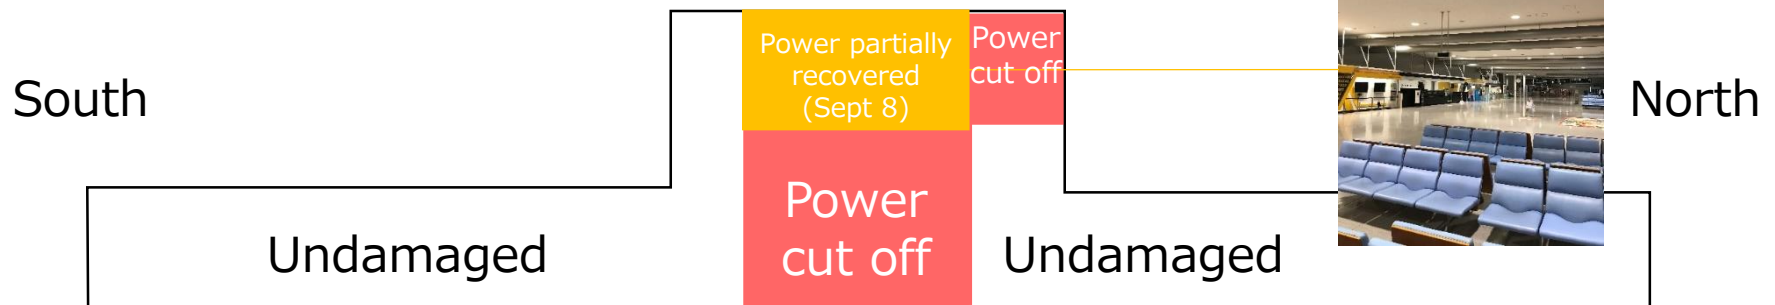
## Electricity recovery situation

No.	Date	September 7	September 14 (After 1 week)	Efforts
1	Sept 7	Lighting: partly outage Disaster prevention: flood damage (partly) AC: flood damage (partly) ES: flood damage on monitoring equipment EV: flood damage on monitoring equipment Service lane: drainage finished	Lighting: operational Disaster prevention: operational AC: partially fixed ES: operational EV: partially fixed	[Lighting] Full recovery expected on Sept 20 [Disaster prevention] Ongoing discussion between parties concerned [AC, ES, EV] Drainage to complete Site investigations to start

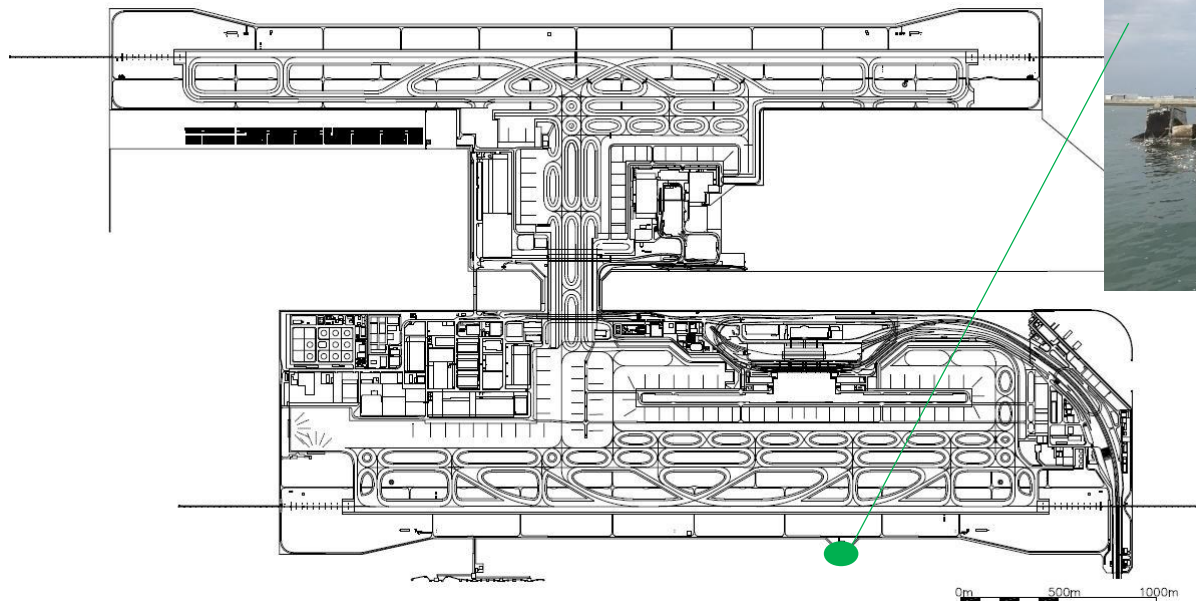
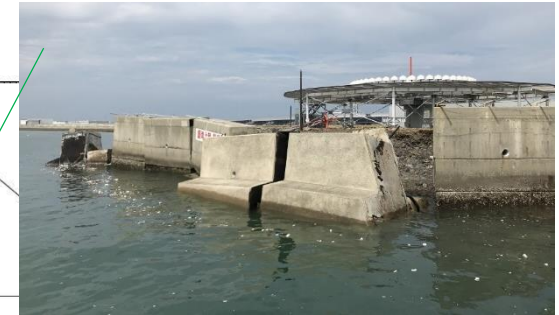
No.	Date	September 7	September 14 (After 1 week)	Efforts
1	Sept 7	Partially collapsed (see below)	Tentatively recovered by installing sandbags and filter units	Installation of sandbags completed. Started installing filter units on Sept.11.
