# KIX Early Recovery Plan

September 12, 2018

# Our Early Recovery Plan

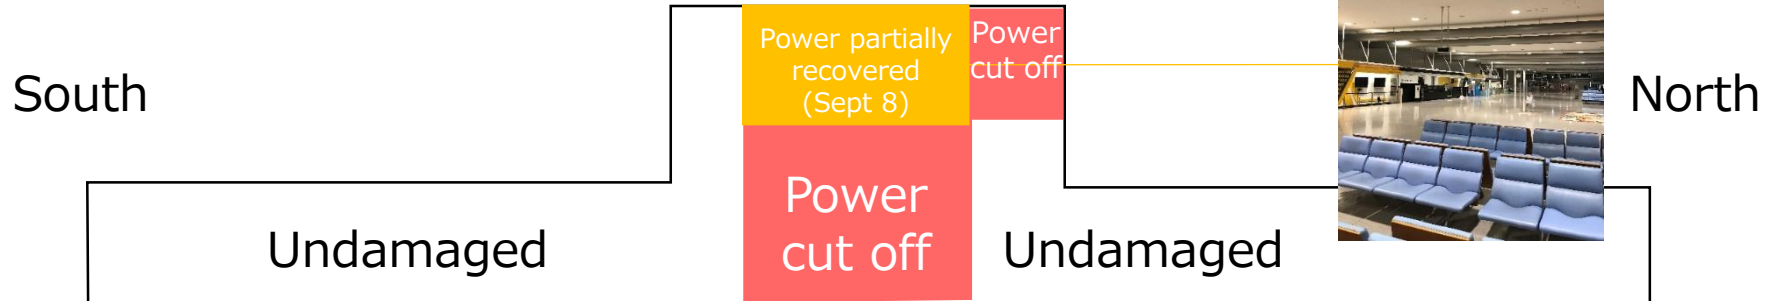
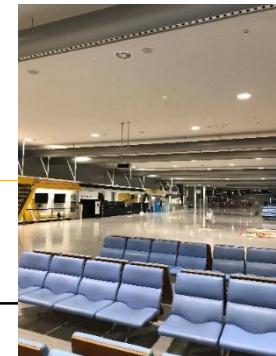
## Electricity recovery situation

No.	Date	September 7	September 14 (After 1 week)	Efforts
1	Sept 7	Lighting: partly outage Disaster prevention: flood damage (partly) AC: flood damage (partly) ES: flood damage on monitoring equipment EV: flood damage on monitoring equipment Service lane: drainage finished	Lighting: operational Disaster prevention: operational AC: <b>operational</b> ES: operational EV: <b>operational</b>	[Lighting] Expected to recover except for North Terminal [Disaster prevention] Safety confirmation on 13th [AC, ES, EV] Test operation after restoration of electricity
